# ASSESSMENT OF THE CURRENT STATE OF THE CONCRETE STRUCTURE OF THE TRIBUNE

*The paper is focused on diagnostics of reinforced concrete structure of the tribune of Závodisko Bratislava. The structure was realized by a combination of monolithic and prefabricated concrete elements as well as steel load-bearing elements. The complex state of the rough construction was evaluated, including the verification survey of the foundation of the construction. Non-destructive and destructive methods were used. Based on the results of the diagnostics and recalculation, it was decided to further progress the finish of the tribune.*

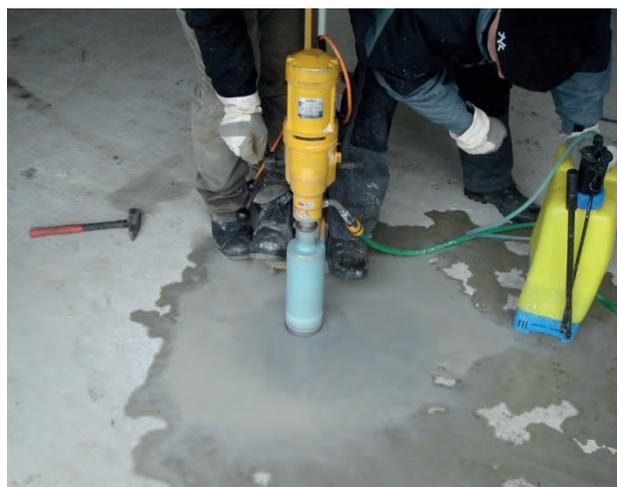
Construction diagnostics showed some differences between the actual realization and the original project documentation. As part of the diagnostics, several control core boreholes were carried out on the slabs and walls (Fig. 4).

Fig. 4. Core borehole in the slab (2nd floor)

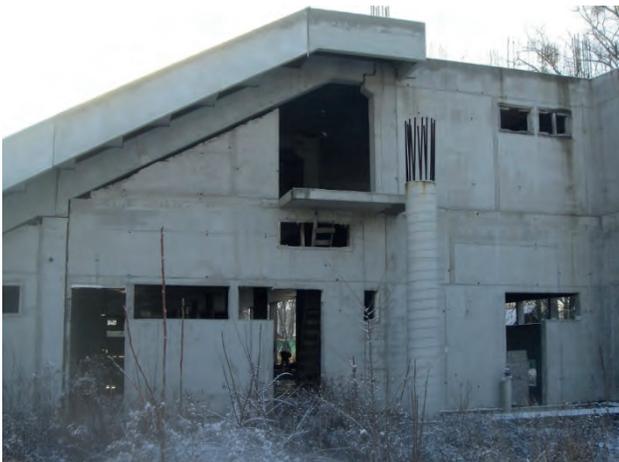
During the inspection, a statically unsuitable solution of openings in the perimeter walls was found (Fig. 5). In this part of the wall there is a ceiling slab and the load-bearing wall is insufficiently supported at one end. It was recommended to statically strengthen this wall.

Fig. 5. Incorrectly static distribution of holes in the load-bearing wall

At the same time, it was recommended to concreting the doorway at the “C” axis, by adding the steel inter-window pillars to hold this wall at the place of window and between the existing doorways. Another possibility was to demolish the wall, whereby the existing ceiling slab has to be sufficiently temporarily supported and a new one have to be concreted with another statically suitable arrangement of the openings.

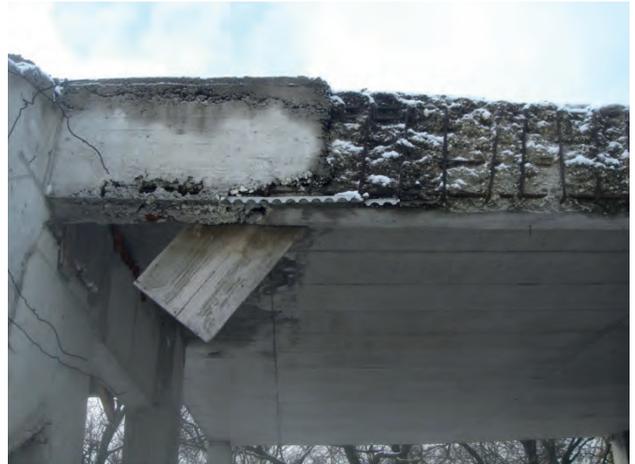
Fig. 6. Part of monolithic lintel with missing cover

In Figure 6 is showed the removed side cover layer of monolithic lintel. Probably the layer was removed due to inaccurate realization and the original cover interfered with the prefabricated elements that were to be placed at this location.

The realized load-bearing walls are in contradiction with the original project documentation. It was recommended to demolish the lintel (Fig. 6) and to concrete a new one, or to use another suitable method of repair.

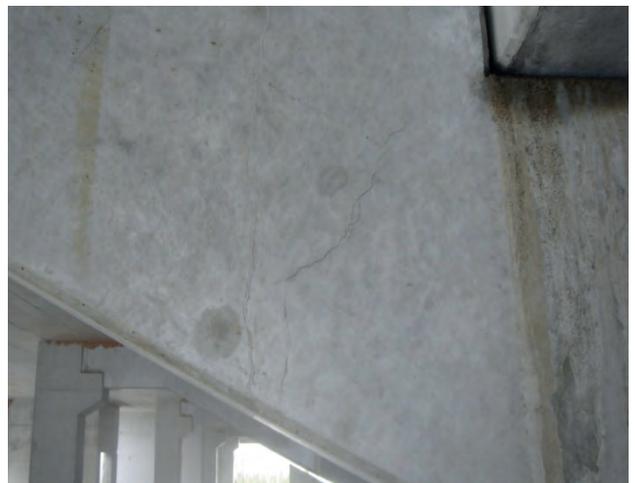
Cracks in the width of 0.1 mm to 0.2 mm were present on the tribune beams (Fig. 7). Cracks occurred on the beams on both floors.

Fig. 7. Cracks on the tribune beam on the 2nd floor

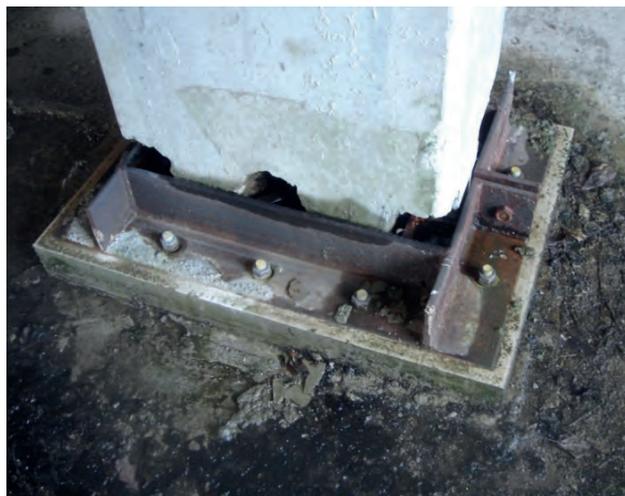
the frame. During the diagnostics, an interruption of the anchorage reinforcement was detected in some places.

Fig. 8. Detail of incorrect anchoring of columns

The anchoring (Fig. 8) of reinforced concrete prefabricated columns with dimensions of 300 mm by 500 mm had to be checked on all columns. It was recommended to dismantle the steel frame along the perimeter and to properly inspect, clean and repair
