ZDZISŁAWA OWSIAK¹
PAULINA SZYMKIEWICZ²
Kielce University of Technology

ACTION OF CHLORIDES ON CONCRETE ELEMENTS OF AN INDOOR SWIMMING POOL

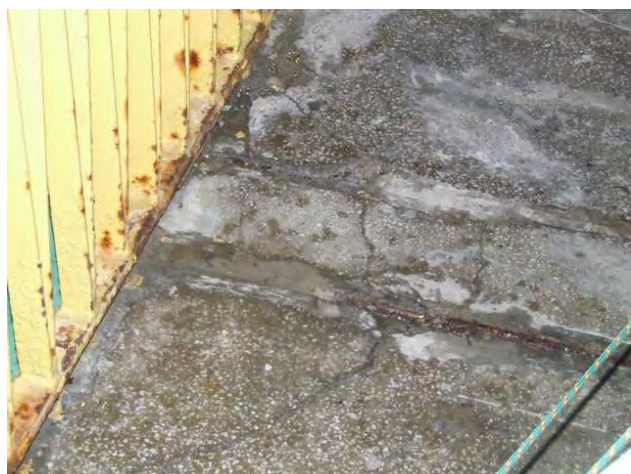
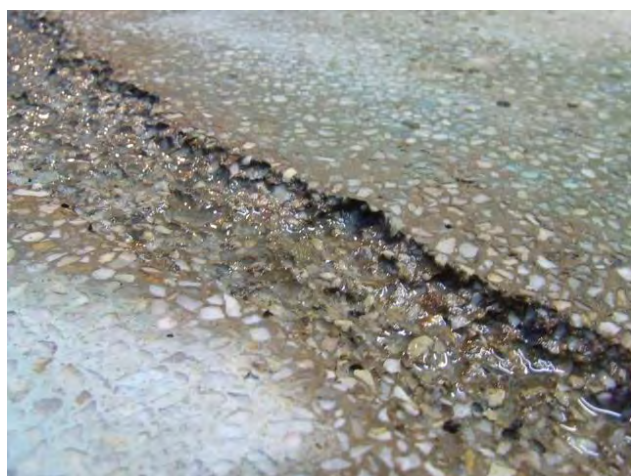
Fig. 1 Corroded area of the concrete floor and exposed rebar in an indoor swimming pool

Anti-corrosion protection of the steel reinforcement is difficult at constant high concentration of chlorides in the atmosphere, even when concrete is dense and chloride transport is slow. With sufficiently high concentration of chlorides in the atmosphere and lowered content of chlorides in the concrete, chloride transport mechanism through the concrete cover is fast enough to initiate corrosion after a relatively short time, even in concretes relatively impermeable for chlorides such as slag concretes with a high content of slag. The corrosion, although delayed, cannot be eliminated in this way. The slower the rate of chloride transport, the longer the service life of concrete when the amount of chlorides present on the concrete surface is maintained at the same level [5]. The conditions to which concrete elements are exposed make initially dense concrete become more pervious over time. Also, the natural process of carbonation promotes chloride contamination. Figure 1 shows deteriorated areas in the indoor swimming pool floor.

cesom korozji chlorkowej. Na rysunku 1 pokazano uszkodzone fragmenty posadzki na krytej pływalni.

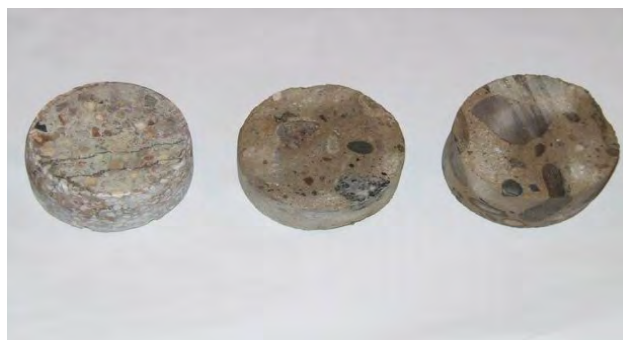
The cylindrical test samples were extracted from the floor of the swimming pool. The samples were 6.9 cm in diameter and 8.95 cm in height. Each sample was cut into specimens corresponding to the concrete layers (Fig. 2), and subjected to laboratory tests.

Fig. 2. Layers of concrete cores

Próbki do przeprowadzenia badań laboratoryjnych pobrano z podłogi basenu. Średnica pobranych próbek walcowych wyniosła 6,9 cm, natomiast wysokość 8,95 cm. Każda z próbek została pocięta na próbki odzwierciedlające warstwy betonu, (rys. 2), na których wykonano badania laboratoryjne. Wykonano badania właściwości fizycznych betonu takie jak gęstość objętościowa [7] i wilgotność, a średnie wyniki badań zamieszczono w tablicy 1. Oznaczono również zawartość chlorków w poszczególnych warstwach betonu [8]. Wyniki badań zamieszczono w tabeli 2.

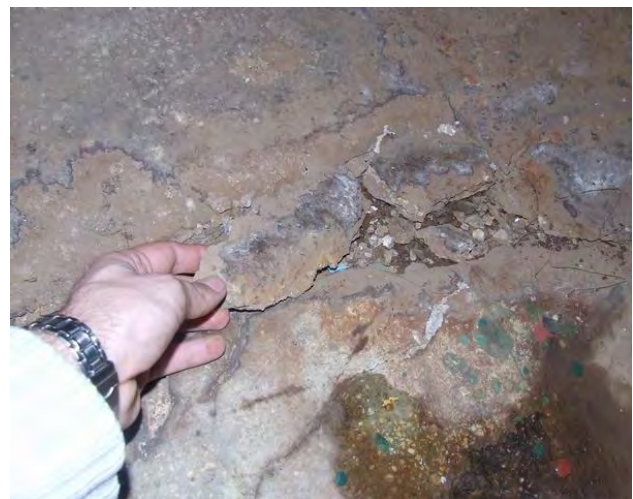
The tests results indicated that the layer of concrete that is located at the greatest depth has the least content of chlorides. Despite this fact, the threshold value of 0.4% was exceeded. This shows the extent to which indoor swimming pool concrete is exposed to continuous action of chlorides. At the chloride ions content in excess of 0.4%, the cover of steel reinforcement deteriorates and the steel surface de-passivates, which leads to reinforcement corrosion. The rust that thereby forms as a corrosion product increases the volume and the tensile forces thus created lead to cracking, fracture and spalling of concrete, as shown in figure 3. Rusty colour appearing on the concrete surface is indicative of corrosion processes in the steel reinforcement.

Fig. 3. Detachment of concrete

Otrzymane wyniki badań wykazały, iż warstwa betonu, która jest najgłębiej położona ma najmniejszą zawartość chlorków. Mimo tego i tak została przekroczona wartość progowa zawartości chlorków w betonie, która wynosi 0,4%. Wyniki te wskazują, jak bardzo narażony jest beton w krytej pływalni na ciągłe działanie chlorków. Po przekroczeniu zawartości 0,4% jonów chlorkowych w betonie, otulina stali zbrojeniowej ulega zniszczeniu i dochodzi do depastywacji powierzchni stali, czego następstwem jest korozja zbrojenia. W trakcie powstawania rdzy, siły rozciągające spowodowane przez zwiększanie się objętości produktów korozji powodują pękanie, rysy i odspojenia betonu, widoczne na rysunku nr 3. Rdzawe zabarwienie betonu świadczy o procesach korozyjnych stali zbrojeniowej.
