# ASSESSMENT OF THE CURRENT STATE OF THE CONCRETE STRUCTURE OF THE TRIBUNE

*The paper is focused on diagnostics of reinforced concrete structure of the tribune of Závodisko Bratislava. The structure was realized by a combination of monolithic and prefabricated concrete elements as well as steel load-bearing elements. The complex state of the rough construction was evaluated, including the verification survey of the foundation of the construction. Non-destructive and destructive methods were used. Based on the results of the diagnostics and recalculation, it was decided to further progress the finish of the tribune.*

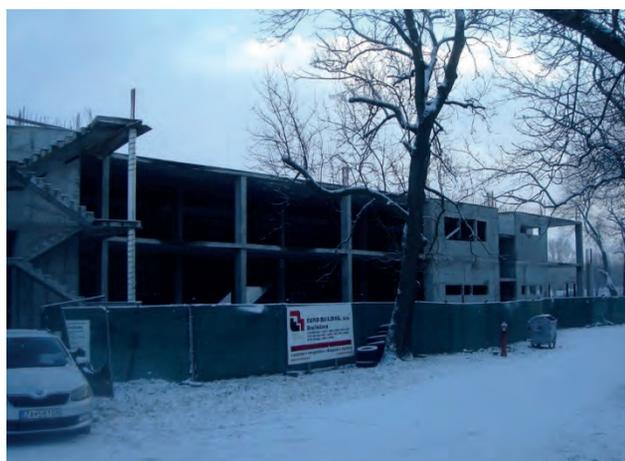
The subject of diagnostics was the object under construction of the Závodisko tribune. At the time of assessment, only two overground floors of the load-bearing structure of the tribune were built (Fig. 3).

Fig. 3. View of part of the tribune under construction (January 2018)

After the building was preserved in February 2012, the object partially under construction dilapidated and until today the building is not completed.
